LAC-PIETE DAM

CALLAWAY COUNTY, MISSOURI

MO 10886

PHASE 1 INSPECTION REPORT NATIONAL DAM SAFETY PROGRAM

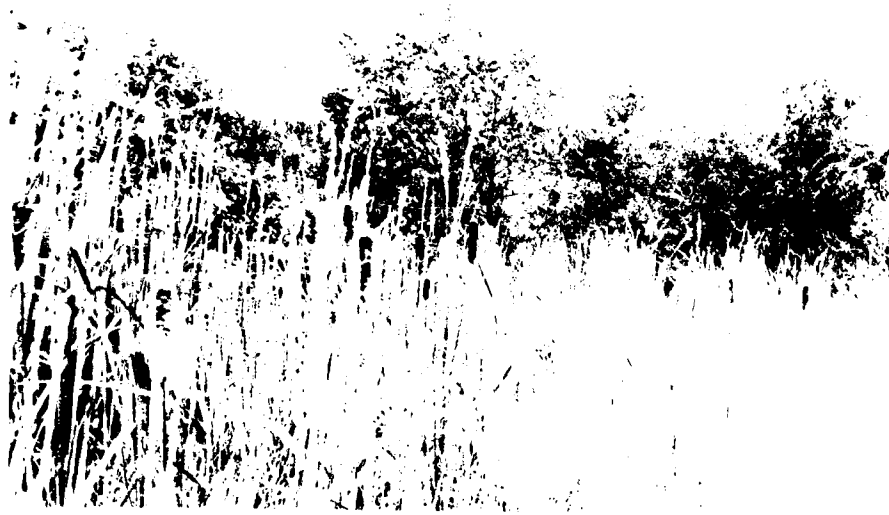
Significant seepage was noted along the downstream toe of the dam from about Q Station 1+00 to 4+50. No boils were observed and seepage appeared to be clear. An 8 inch cast iron sewer line runs along the toe of the dam (approximately Q Stations 5+00 to 3+00)

PHOTO NO. 6
SEEP AREA BELOW
CENTERLINE STA. 3+50.

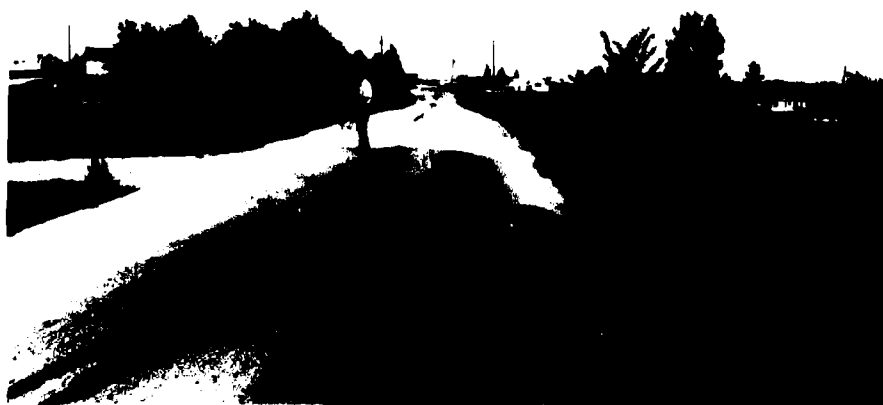
PHOTO NO. 7
LOOKING ALONG
CENTERLINE OF
DAM FROM RIGHT
TO LEFT. COUNTY
ROAD CROSSES DAM.
